**View From Minimally Invasive
Incision of Mitral Valve
Showing Flail (torn) Posterior Leaflet**

Postoperative 3D Echo Image After Minimally Invasive Mitral Valve Repair

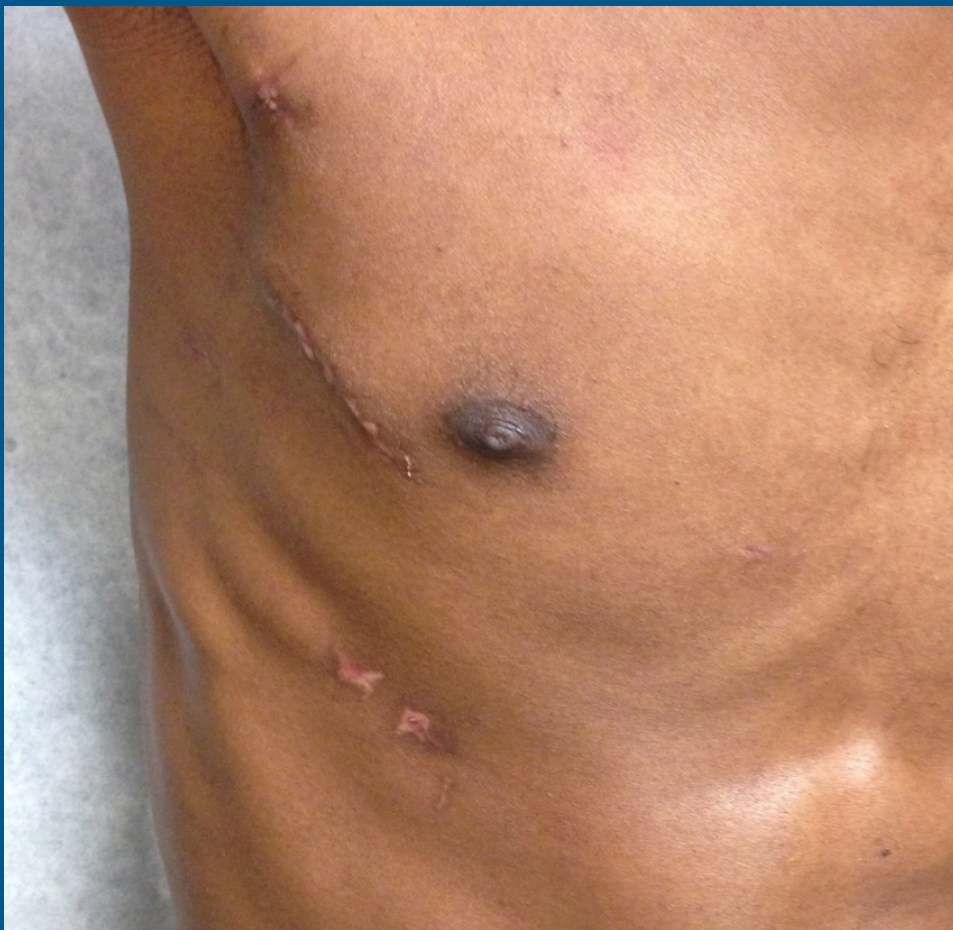
Incision Site for Minimally Invasive Mitral Valve Repair

Patient 1: 3 weeks after surgery

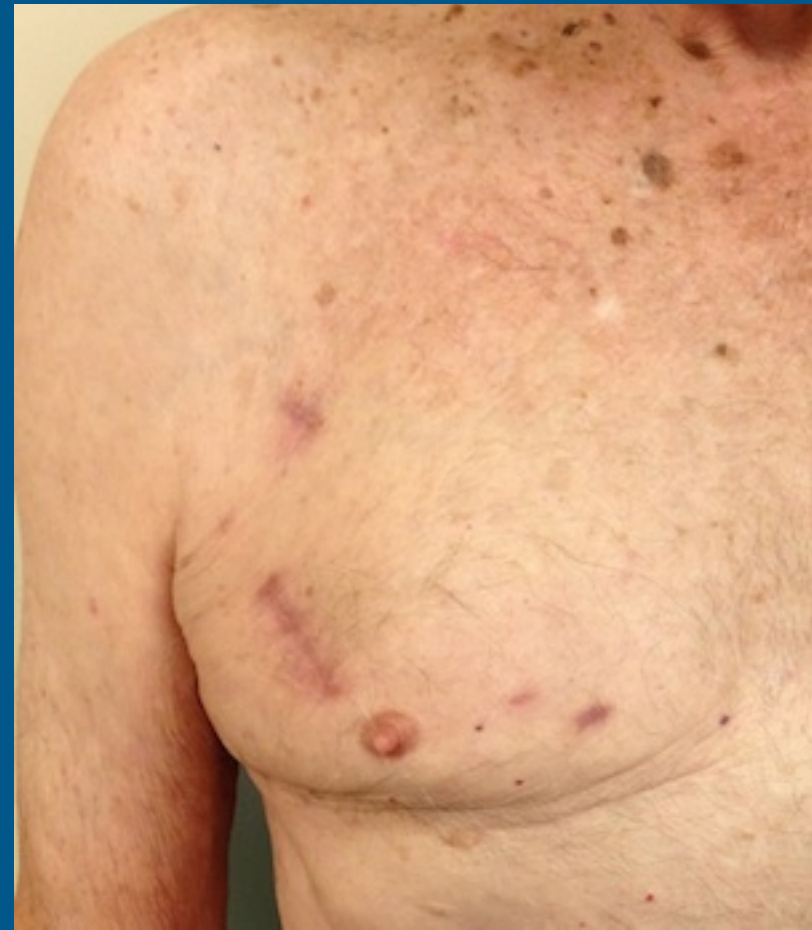
Patient 2: 2 months after surgery
